Drait Translation 629 July 1977

TAILINGS COFFERDAMS
ON PERMAFROST FOUNDATIONS
IN YAKUTSKAYA ASSR

G.I. Kuznetsov and S.V. Zaslavskiy

CORPS OF ENGINEERS, U.S. ARMY
COLD REGIONS RESEARCH AND ENGINEERING LABORATORY
HANOVER, NEW HAMPSHIRE

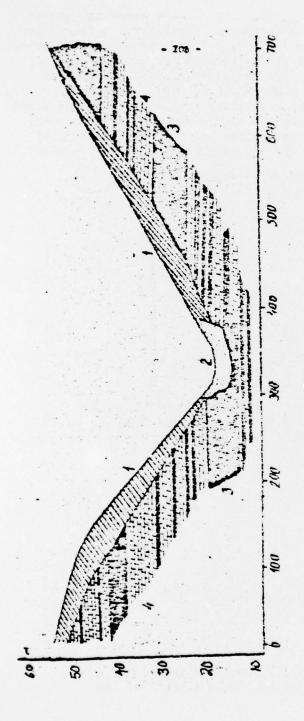
All dams are characterized to a greater or lesser extent by the following foundation structure. Frozen, strongly fractured, and in places icy bedrock is made up of homogeneous or vertically and horizontally alternating strata of clay, marl and limestone (aleurolites and sandstones are occasionally encountered). As these rocks thaw under the influence of the heating action of tailings dumps, constant filtration occurs in the fractured strata, accelerating the permafrost degradation process. The filtration discharges continue throughout the year, as indicated by the heavy flows of filtration waters that seep out in the lower reach, producing large ice formations in the winter.

Figure 1. Characteristic permafrost-geological conditions in section line of dam: 1 -- ice-saturated loose clay and silt soils; 2 -- filtering [one word illegible] sediments; 3 -- argillaceous permafrost bedrock; 4 -- fractured rock, filtering after thawing.

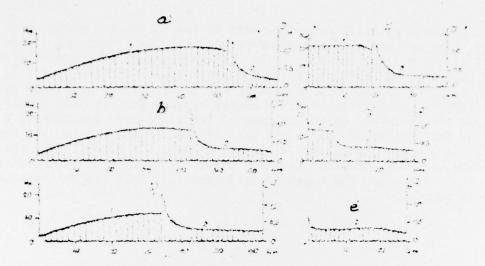
Filtration was modeled in an ETDA-9/60 electro[illegible]. The effect of ice buildup on the discharge characteristics of the filtration flow and length of the seepage section are explained in Figure 6.

In consideration of the water permeability of the thawed layer of loamy clay in the base and body of a pioneer dam, filled from such material ( $K_{\hat{\mathbf{f}}} = 0.18 \text{ m/day}$ ), the [possibly magnitude] of the hydrodynamic resistance under the ice formation increases substantially, and the discharge gradients in the [possibly lower] part of the seepage zone increased to an even greater extent.

As the ice formation builds up from a height of 12.0 to 17.3 m both the hydrodynamic resistance under the ice and the discharge gradients in the lower part of the seepage section increase. At the same time the length of the seepage section decreases appreciably.

Figure 6. Diagrams of filtration back pressure under ice formation and discharge gradients of filtration flow in seepage zone: 1 -- back pressure diagrams; 2 -- discharge gradient diagrams; H -- magnitude of back pressure, M; I -- magnitude of discharge gradient; a, b, c -- in consideration of the water permeability of loamy clay [one word illegible] and foundation; d, e, f -- water permeability not considered [remainder of caption illegible].

The buildup of ice on the slope has an unfavorable effect on the [one word illegible] hydrodynamic characteristics of the filtration [one word illegible] and reduces the local stability of the slope in the [possibly seepage] section.

The following suggestions are offered for reducing the negative influence of filtration and [possibly icing] on the stability of a tailings dump:

1) at existing tailings dumps -- slope drainage and filling on rocks [one word illegible] of constant seepage of the filtration flow and icing (the drainage system is protected from freezing by filling with a heatinsulating layer of local [one word illegible] soil);

2) at planned tailings dumps -- antifiltration system and internal drainage, built in consideration of thawing and sharp increase of filtration in fractured zones of the permafrost foundation.
